Evaluation Report 16

Hesston 5800 Rounder

A Co-operative Program Between

HESSTON 5800 ROUNDER

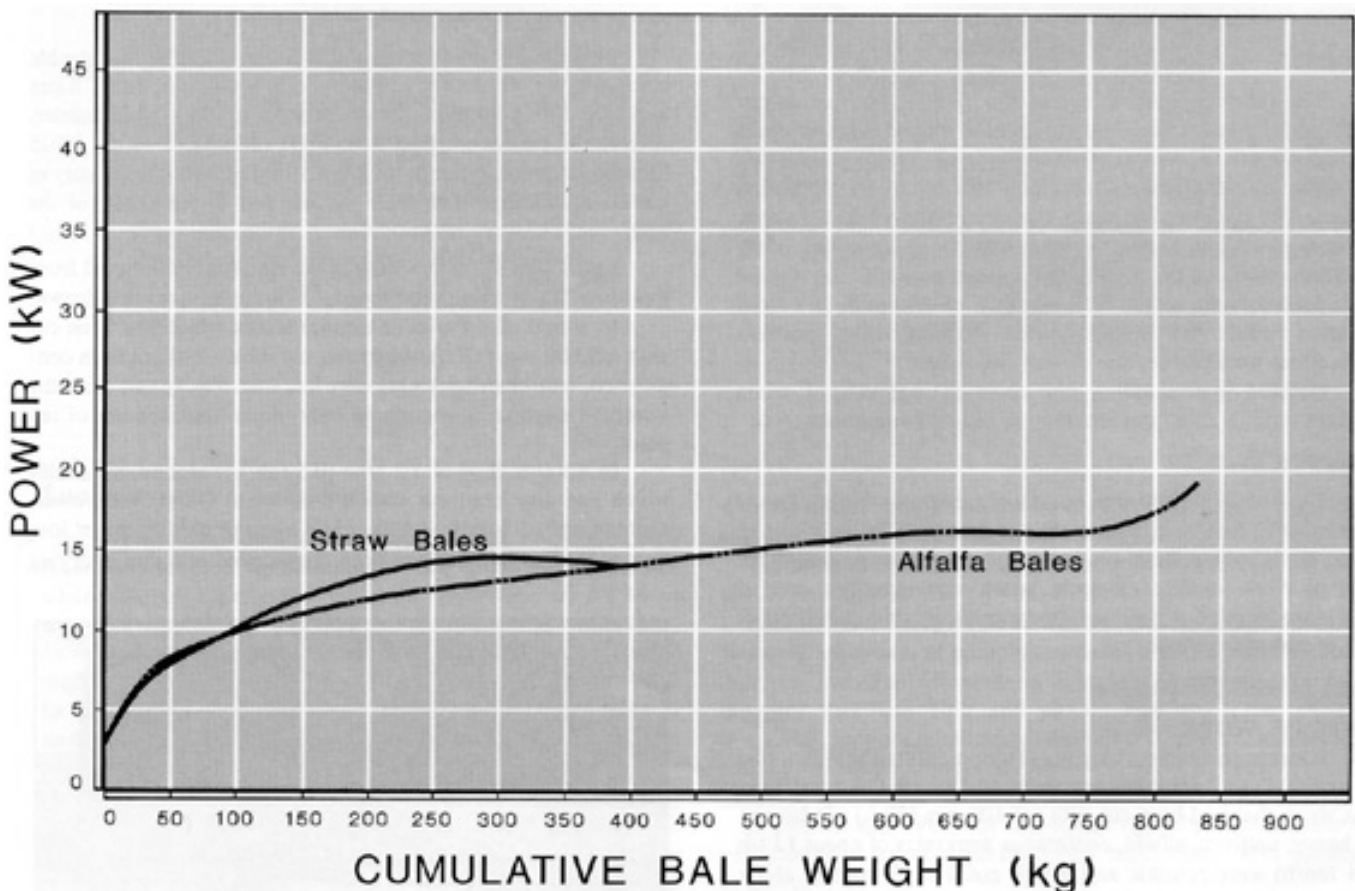
Power Take-Off Requirements: Figure 5 shows the power take-off input for the Hesston 5800 in alfalfa and in wheat straw. The power input is plotted against bale weight to show the power requirements as a bale is being formed. The power input varied from 3 kW (4 hp) at no load to a maximum of 19 kW (26 hp) in alfalfa and 14 kW (19 hp) in wheat straw.

Figure 5. Power Consumption of the Hesston 5800 During Bale Formation.

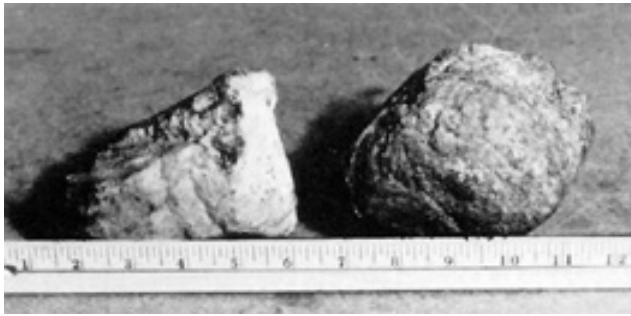
Figure 7. Typical Size of Rocks Which May Wedge Between the Compression Rollers.

The pickup tines are cam controlled and can be adjusted to advance or retard the pickup tine pattern. Pickup tine timing adjustment is outlined briefly in the operator's manual. The pickup tines could be adjusted for very aggressive picking action however, in stony fields, many stones were picked at all settings. Numerous stones were thrown at the operator by the pickup and on three occasions, stones jammed between the compression rollers.

Two hazardous situations were encountered when baling in stony areas. The pickup occasionally threw small stones towards the tractor and the operator. The operator's manual recommends that safety glasses be worn in stony fields. Another hazardous situation occurred when the pickup fed large stones into the compression rollers. Stones wedged between the compression rollers, either stopping them or scraping on the steel roller and emitting sparks. Figure 7 shows two rocks which wedged in the compression rollers. One of these started a fire from the sparks generated. The operator's manual recommends that a fire extinguisher be mounted on the baler.
